DEPARTMENT OF TRANSPORTATION

Quality Assurance and Source Inspection

Contract #: 04-0120F4Cty: SF/ALA Rte: 80 PM: 13.2/13.9File #: 99.28**WELDING INSPECTION REPORT****Resident Engineer:**Siegenthaler, Peter**Address:** 333 Burma Road**City:** Oakland, CA 94607**Report No:** WIR-017424**Date Inspected:** 15-Oct-2010**Project Name:** SAS Superstructure**OSM Arrival Time:** 700**Prime Contractor:** American Bridge/Fluor Enterprises, a JV**OSM Departure Time:** 1900**Contractor:** Zhenhua Port Machinery Company, Ltd (ZPMC)**Location:** Shanghai, China**CWI Name:** Li Yang and Zhu Zhong Hai**CWI Present:** Yes No**Inspected CWI report:** Yes No N/A**Rod Oven in Use:** Yes No N/A**Electrode to specification:** Yes No N/A**Weld Procedures Followed:** Yes No N/A**Qualified Welders:** Yes No N/A**Verified Joint Fit-up:** Yes No N/A**Approved Drawings:** Yes No N/A**Approved WPS:** Yes No N/A**Delayed / Cancelled:** Yes No N/A**Bridge No:** 34-0006**Component:** OBG Trial Assembly**Summary of Items Observed:**

WELDING INSPECTION REPORT

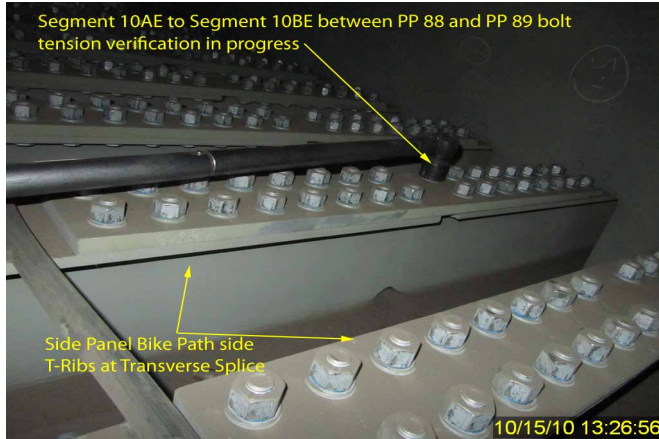
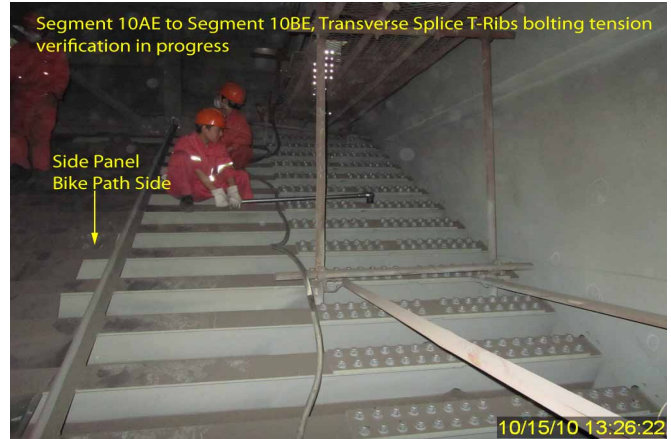
This QA Inspector witnessed final bolt tension verification on bolts connecting T-Rib to T-Rib for Transverse Splice at Side Panel Bike Path Side (from work point E1 towards E3), Bottom Panel (from work point E3 towards E4) and Cross Beam side (from work point E4 to E6) between Panel Point (PP) 88 to PP 89 for Segment 10AE to 10BE. Inspected the bolt tensioning on a random basis and found the tension to be in general compliance.

The bolt sizes used were M22 x 70 RC Lot # DHGM220038 and the final torque value established was 480 N-m.

The Manual Torque wrench used was Serial No. XO2-666. Please reference the pictures attached for more comprehensive details.
